## CRITICAL REVIEW

Cite this: *Environ. Sci.: Water Res. Technol.*, 2026, 12, 14

## Decentralized UV disinfection systems in rural areas or low-resource contexts: a case study compilation

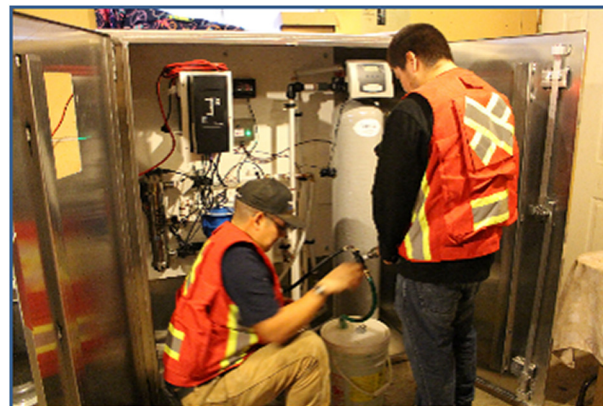
Fig. 3 The Lytton POE systems, with the low-pressure UV system, were installed in a secured enclosure, placed inside residents' homes.

An emergency solenoid shut-off valve was located downstream of the UV lamp and was normally closed when the water was not in use, preventing water from reaching the consumer. It also closed if the UV dose was less than 40 mJ cm<sup>-2</sup> and if the system lost power, was unplugged or if the UV lamp failed to turn on. In

response to a power failure, the solenoid valve would close, as it would no longer be powered open. The UV unit had a sensor to detect lamp intensity. If a safe UV dose was not achieved during the warmup cycle (if the intensity went below a set value calculated for the required dose), an alarm occurred, and the solenoid remained closed. A backup battery was available for temporary power (approximately providing up to one hour power for continuous operation) in the case of a power failure.

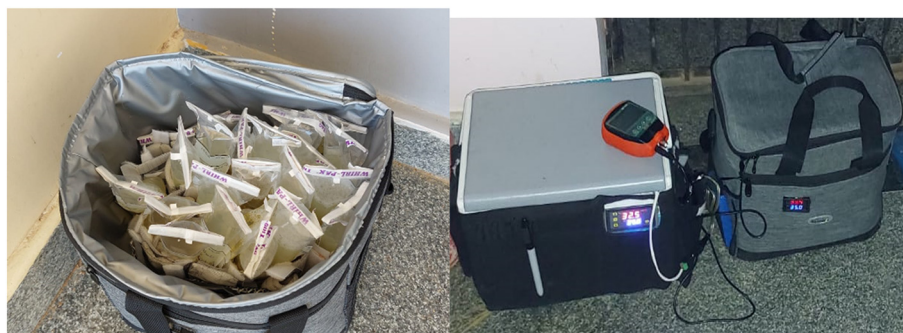
Fig. 8 Field incubator and test kits.

rural areas with intermittent electricity supply. The parts of the incubator were purchased in India and built in the field. Fig. 8 shows the field incubator and the Aquagenx field test

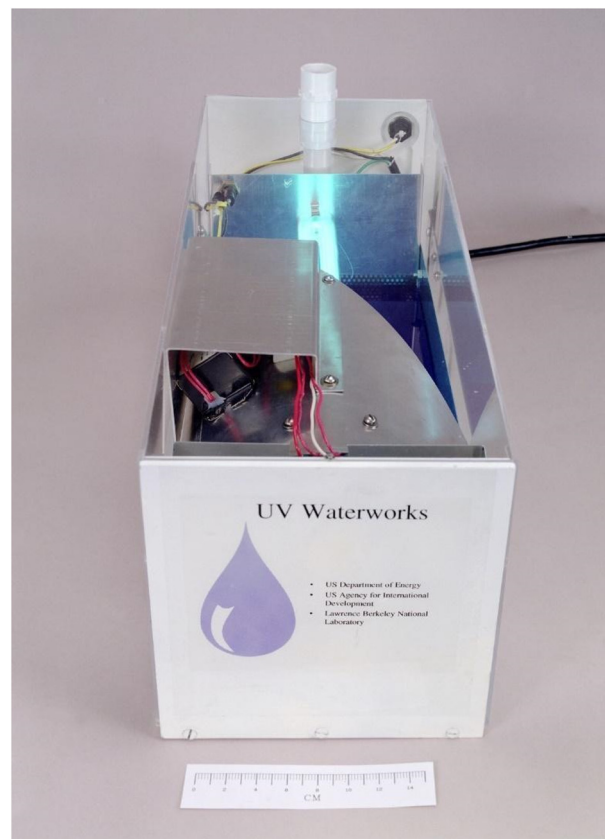
**Fig. 13** UV waterworks, built with a glass cover for exhibits and displays to explain how the technology works.

The design team created an affordable and effective device that disinfects water using the equivalent of a 60 W light bulb at a cost of two cents per ton of water treated, treating 15 LPM, enough for 500 to 1500 people (Fig. 13). The unit delivers  $120 \text{ mJ cm}^{-2}$  to the water (three times higher than the  $40 \text{ mJ cm}^{-2}$  often recommended in the literature and regulations for drinking water disinfection, i.e., ANSI/NSF-55 class A). It was designed to treat water with a UV extinction coefficient equal to that of the average effluent from United States municipal wastewater treatment plants. In laboratory testing with *E. coli* in dechlorinated tap water in Berkeley, UV Waterworks achieved a 6 log reduction in *E. coli* CFU (colony forming units). UV Waterworks was tested by third-party laboratories to ensure it could kill 15 different pathogenic bacteria (including *Campylobacter jejuni*, *Shigella*, *Salmonella typhi*, *Vibrio cholerae* and *Escherichia coli*) and multiple

influent, a system was created with no solid surfaces between the UV source and the water, ensuring that the UV disinfection remained unaffected by chemical or biological fouling. Positioning the UV lamp above the water flow also improves lamp life, output, and UV fluence. Operating in the air keeps the temperature stable, improving performance and longevity while preventing fluctuations that reduce UV output.<sup>40</sup> Avoiding contact with water minimizes fouling, corrosion and moisture damage, reducing maintenance needs.<sup>41</sup>

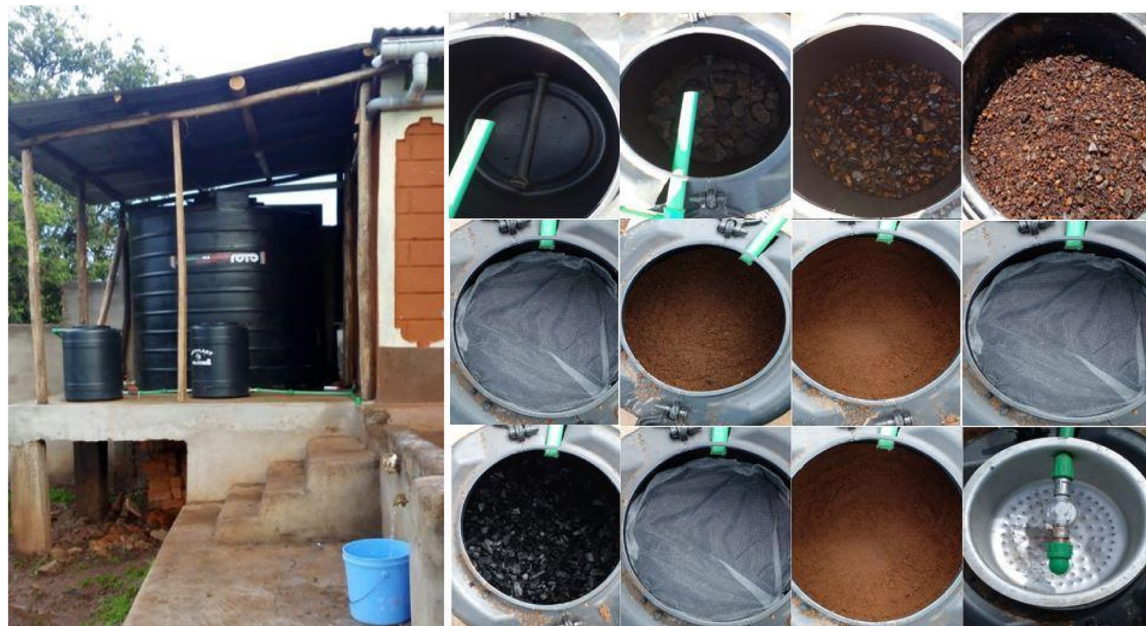
Fig. 17 (Left) Rainwater collection, filtration and disinfection system. (Right) Biosand and biochar layers within the filtration system.

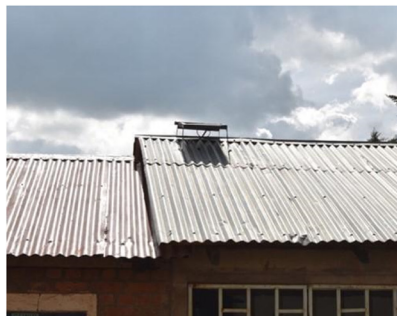
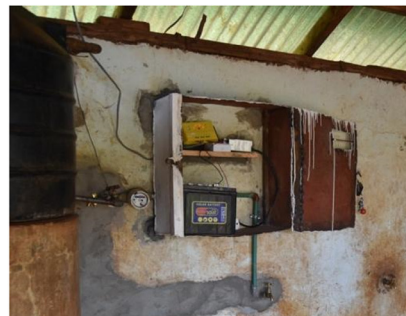
**Fig. 18** System components that were designed and constructed by the welder; (left) a solar panel bracket holds the panel in place on the roof and locks so the panel cannot be stolen, and (right) a box to protect the system from tampering.

All of the UV system components were functional in 2020, but they were not being used consistently due to technical constraints. One major barrier was a problem with energy surges that were not properly mitigated by the charge controller in the system. There were issues with both locally and United States-sourced low-cost charge controllers. As a result, lamps would frequently burn out and need to be replaced. A surge protector was installed (which was unavailable locally), but the surges were frequent, requiring that an operator check the system before each use, which was not practical. Further, parts for the VIQUA VT1 system were not available locally and needed to be sourced from a company in Uganda (which needed to order them from Canada). Alternate UV systems were available at the local water equipment supplier, Davis and Shirtliff. Rigorous testing of locally available supplies and design of treatment systems using only these supplies would have prevented many of the technical issues encountered.

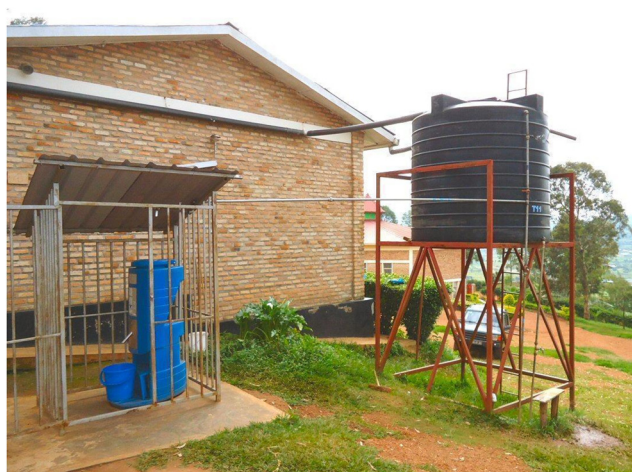
Fig. 25 A Naiade (on the left) and rainwater harvesting tank on a primary school in Kigali, serving 240 children and 20 staff members.

Twenty-three Naïade units have been installed at schools (Fig. 25) and small hospitals in Rwanda and maintained by the Impala Foundation, and some of these units have been operational for over 12 years now. Units were financed by the Dutch Soroptimists organization.

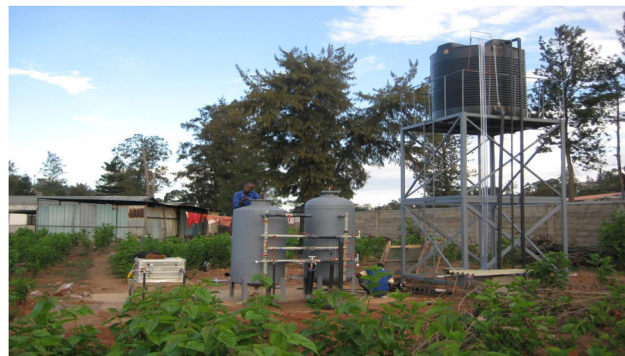
**Fig. 27** An example of the Manna Energy Limited water treatment system. The system is installed in-line with existing water pipes. On the right is an elevated backwash tank. In the center is a gravel filter and a pressurized sand filter. On the left is the solar photovoltaic-powered UV system.

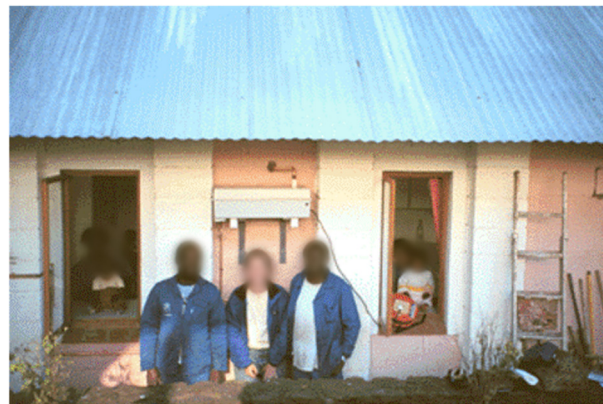
Fig. 29 UV Waterworks 2.0 unit installed on the exterior wall of the kitchen at the Lily of the Valley HIV-Hospice near Durban, South Africa.

The design team created a device to disinfect water using the equivalent of a 60 W light bulb at a cost of two cents per ton of water treated, treating 15 LPM, enough for 500 to 1500 people, depending on how many hours the unit is operated

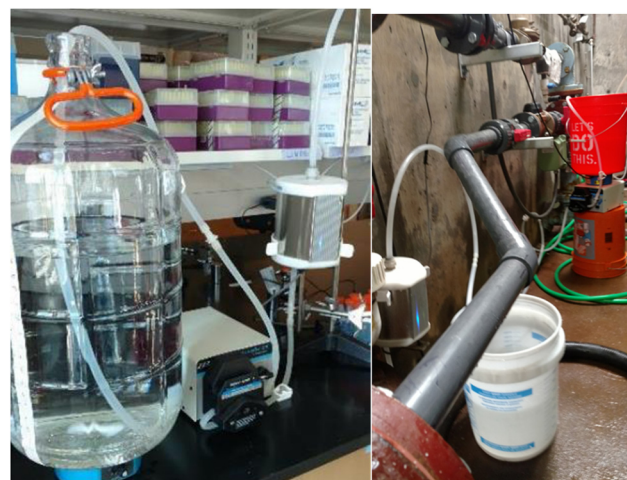
**Fig. 35** UV LED reactor disinfection performance was assessed under varying conditions at bench scale (left) to develop a predictive model that was used to assess performance during challenge testing after pilot installation (right).

One objective of this research was to validate UV LED reactor disinfection performance at bench scale across a range of flow rates and UV transmittances to develop a predictive model for disinfection (Fig. 35). In the second objective, the LED reactor was installed in the first long-
