CRITICAL REVIEW

Decentralized UV disinfection systems in rural areas or low-resource contexts: a case study compilation

Water disinfection using ultraviolet (UV) light is an emerging tool for improving access to safely managed drinking water in rural areas and low-resource regions. However, there is little information comparing existing UV systems in those contexts, towards improving the effectiveness of future UV systems. This work presents 19 case studies of small, decentralized UV water disinfection systems being used during the last 30 years to improve water access. The case studies cover a wide range of project types, including schools, hospitals, communities, households and healthcare facilities, spanning four continents. A variety of energy sources, water sources and social environments are also reviewed. In general, the use of UV immediately improved the microbiological quality of the water; however, long-term tracking of system performance is largely missing. UV system effectiveness was limited by several factors, including the potential for recontamination after UV disinfection, insufficient maintenance, and the absence of regulatory frameworks that allow the more wides

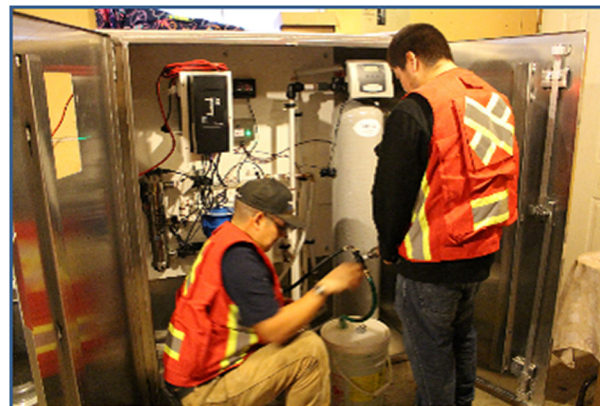
Fig. 3 The Lytton POE systems, with the low-pressure UV system, were installed in a secured enclosure, placed inside residents' homes.

An emergency solenoid shut-off valve was located downstream of the UV lamp and was normally closed when the water was not in use, preventing water from reaching the consumer. It also closed if the UV dose was less than 40 mJ cm⁻² and if the system lost power, was unplugged or if the UV lamp failed to turn on. In

response to a power failure, the solenoid valve would close, as it would no longer be powered open. The UV unit had a sensor to detect lamp intensity. If a safe UV dose was not achieved during the warmup cycle (if the intensity went below a set value calculated for the required dose), an alarm occurred, and the solenoid remained closed. A backup battery was available for temporary power (approximately providing up to one hour power for continuous operation) in the case of a power failure.

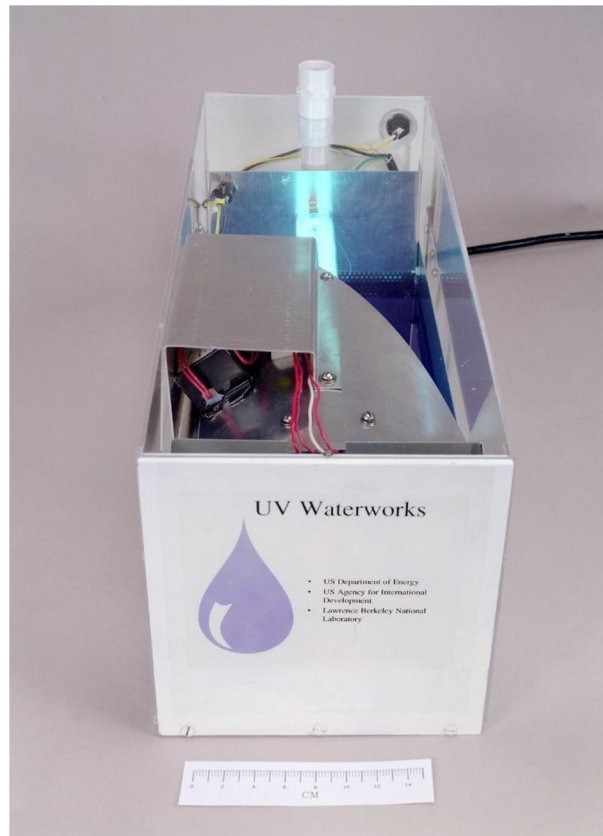
Fig. 13 UV waterworks, built with a glass cover for exhibits and displays to explain how the technology works.

influent, a system was created with no solid surfaces between the UV source and the water, ensuring that the UV disinfection remained unaffected by chemical or biological fouling. Positioning the UV lamp above the water flow also improves lamp life, output, and UV fluence. Operating in the air keeps the temperature stable, improving performance and longevity while preventing fluctuations that reduce UV output.⁴⁰ Avoiding contact with water minimizes fouling, corrosion and moisture damage, reducing maintenance needs.⁴¹

The initial design was constructed of welded stainless steel, at a cost of \$900 USD, consumed 40 W and reduced the bacterial colony forming units (CFU) per 100 mL at 30 LPM from 100 000 to less than one, *i.e.*, disinfection that meets WHO and EPA standards.

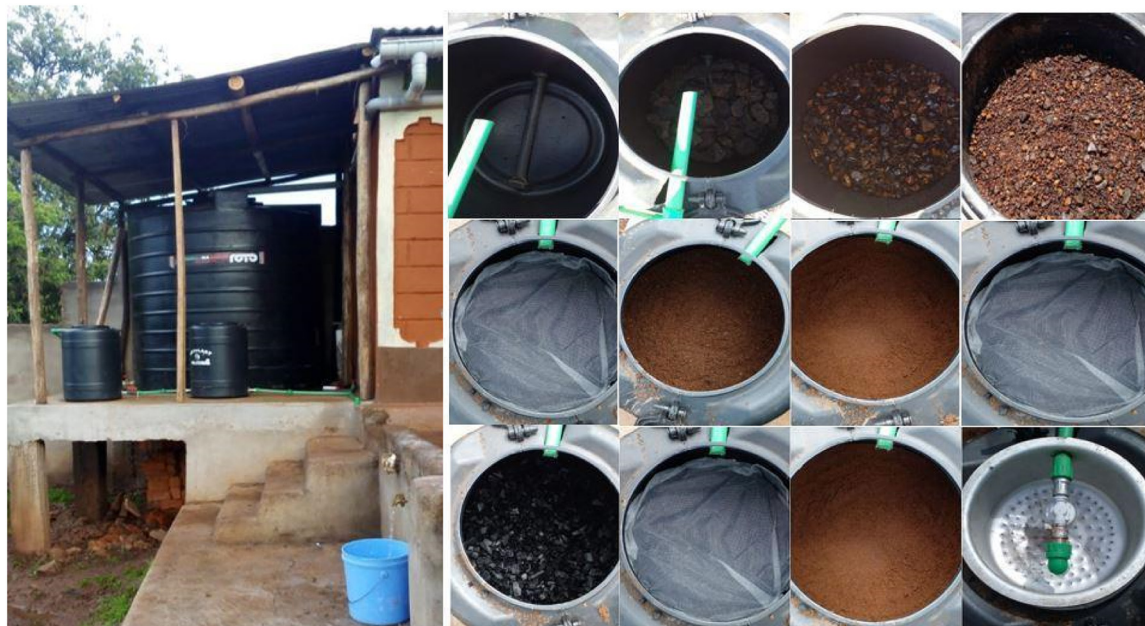
Fig. 17 (Left) Rainwater collection, filtration and disinfection system. (Right) Biosand and biochar layers within the filtration system.

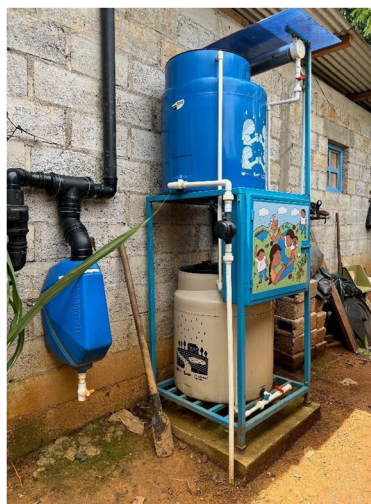
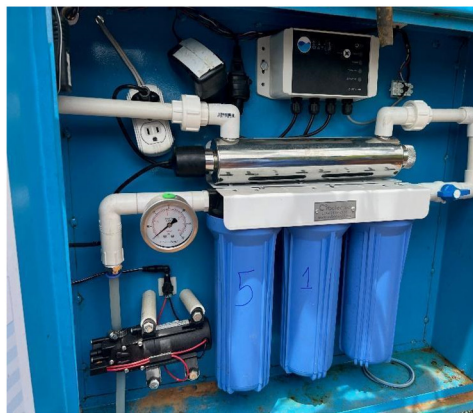
Fig. 20 The 250 L SAFEWATER system (left) with the encased LP UV lamp and activated carbon filters (right).

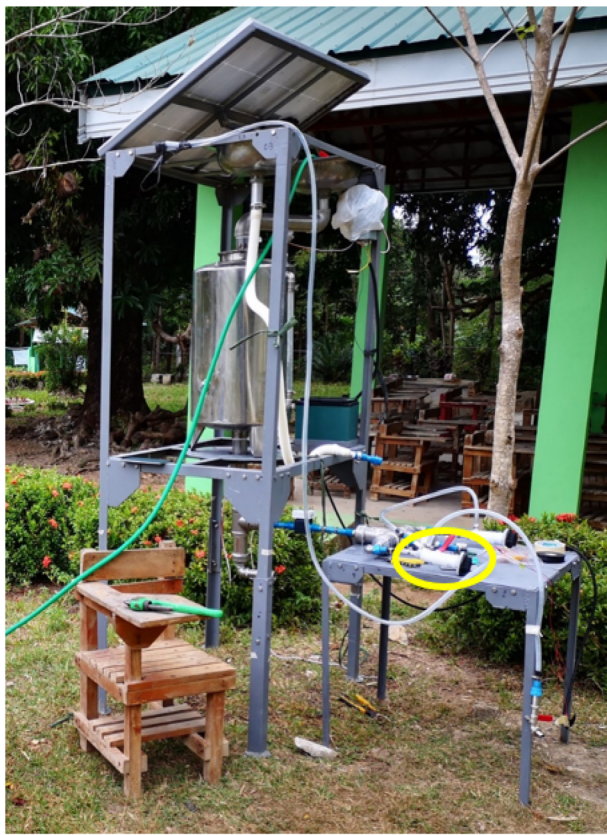
Fig. 22 Pilot setup of solar-powered UV LED water disinfection system in Panobolon Island, Guimaras, Philippines. The UV LED module is enclosed in the yellow circle.

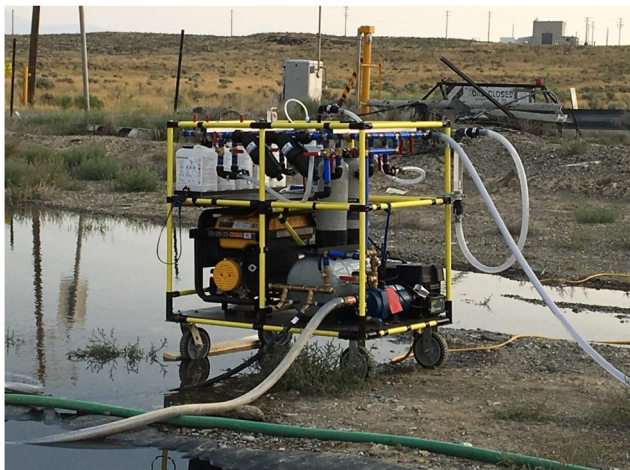
Fig. 33 WOW cart.
