## Survey of green building water systems reveals elevated water age and water quality concerns†

William J. Rhoads,\* Amy Pruden and Marc A. Edwards

Widespread adoption of innovative water conservation strategies has potential unintended consequences for aesthetics and public health. A cross-section of green buildings were surveyed and compared to typical conventional buildings in terms of water retention time (*i.e.*, water age), water chemistry, and levels of opportunistic pathogen genetic markers. Water age was estimated to be 2–6.7 months in an off-grid office, an average of 8 days in a Leadership in Environmental Engineering Design certified healthcare suite, and was increased to 2.7 days from 1 day due to installation of a solar “pre-heat” water tank in a net-zero energy house. Chlorine and chloramine residuals were often completely absent in the green building systems, decaying up to 144 times faster in premise plumbing with high water age when compared to distribution system water. Concentration of 16S rRNA and opportunistic pathogen genus level genetic markers were 1–4 orders of magnitude higher in green *versus* conventional buildings. This study raises concerns with re

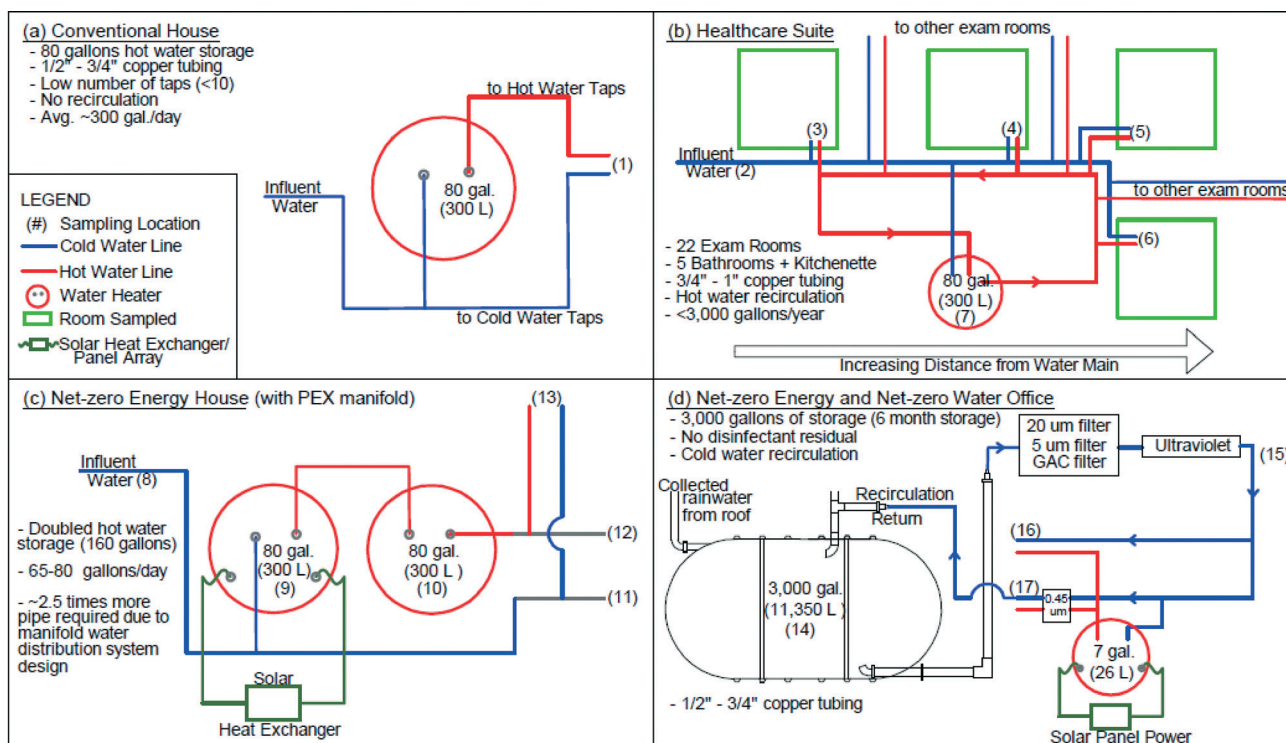
Fig. 1 Plumbing schematics and sampling locations for each field site.

Note: Numbers 1-17 in parentheses indicate sampling locations referred to in Table 2.

Four buildings with a cross-section of energy and water conservation strategies were surveyed and sampled to explore effects of green plumbing systems on water quality (Table 1). The buildings included a conventional house with no conservation features (Fig. 1a), a healthcare suite (Fig. 1b), a net-zero energy house (Fig. 1c), and a net-zero energy and net-zero water office building (Fig. 1d).

minutes of flushing was necessary to establish a chloramine residual similar to that present in the main distribution system (Fig. 2a). Taps at these locations are typically used for 15–30 seconds at a time; therefore, it is unlikely that a chloramine residual is ever present in portions of this plumbing system. Approximately 30 minutes of flushing was required at the net-zero energy house to establish a residual in the cold water system during the first site visit. In contrast, the conventional home had a residual of 0.71 mg L<sup>-1</sup> chlorine as Cl<sub>2</sub> in stagnant cold water. The water heaters at the net-zero house had <0.15 mg L<sup>-1</sup> chlorine as Cl<sub>2</sub> during a 20 minute flush due to the added storage volume and water age associated with the solar heater (Fig. 1c).

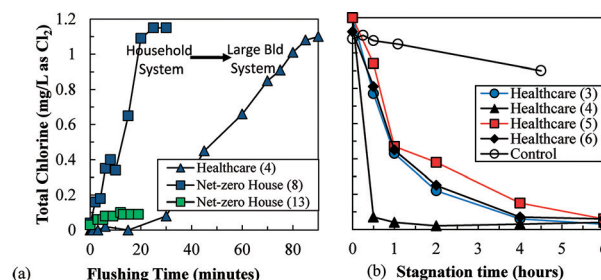
Note: Sampling locations indicated in parenthesis in the figure legends correspond to sample locations depicted in Figure 1.

**Fig. 2** Total chlorine residual concentrations (a) as a function of stagnation in one room at the healthcare suite (large building system above), a tap near the head of the building at the net-zero house (household system above), and during three showering events at net-zero house, and (b) as a function of stagnation in several rooms at FS#1 (control represents identical water placed in a glass container with no head space).

The healthcare suite also showed evidence of very rapid disinfectant residual decay. In all four exam rooms monitored, the first-order decay rate of chloramine in the plumbing was 20–144 times greater than in well-flushed (>80 minutes) water collected from the same tap and placed into a glass container with no headspace (*i.e.*, “control,” Fig. 2b). The highest rate of decay (sample location 4) was observed in
