Cite this: *Environ. Sci.: Adv.*, 2025, 4, 606

# Impact of wildfires on the drinking water catchment for the capital area of Iceland – a case study†

Maria J. Gunnarsdottir, <sup>a</sup> Sigrún Tómasdóttir, <sup>b</sup> Olgeir Örlygsson, <sup>b</sup>  
Hrund Ó. Andradóttir <sup>a</sup> and Sigurdur M. Gardarsson <sup>a</sup>

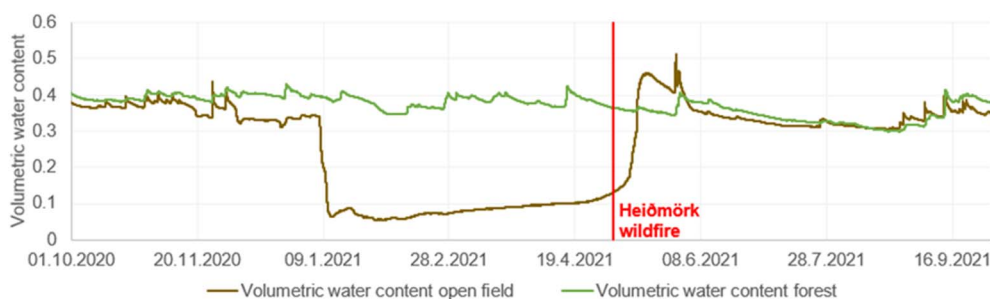
Fig. 5 Volumetric water content in soil in pine forest (green) and open field (brown) from 1.10.2020 to 1.10.2021 measured in the water protection area ML. The vertical line shows the timing of the wildfire.

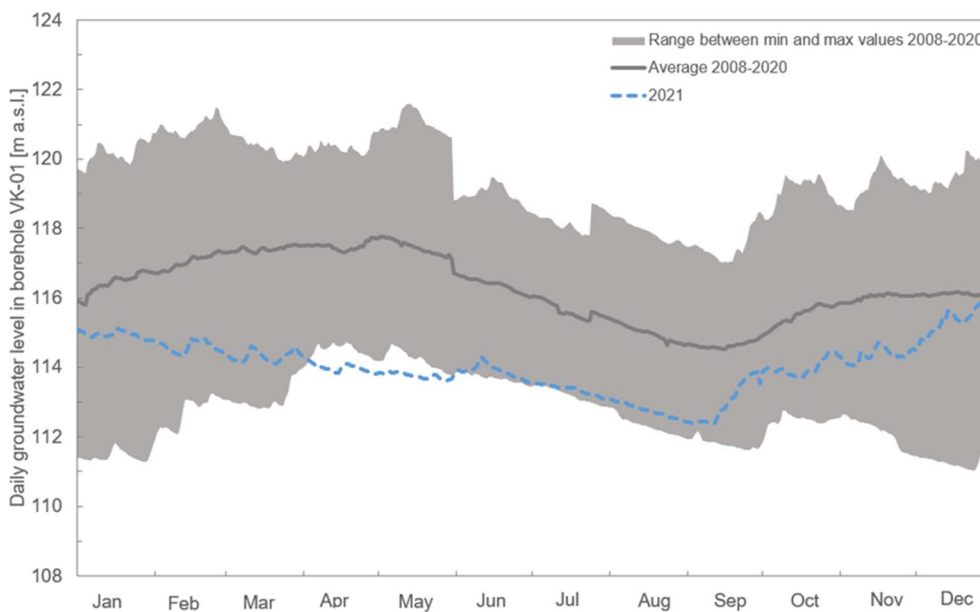
Fig. 6 Average groundwater level for VK-1 for the period 2008–2020, where the shaded area shows the range of the max mean values. The blue line shows the level for 2021.

values were used. Records of the historical groundwater level in the VK production zone east of the wildfire were available from 2008. Daily averages from borehole VK-1 were used.
