## PAPER

Cite this: *Energy Environ. Sci.*,  
2025, 18, 264

## Removal of residual contaminants by minute-level washing facilitates the direct regeneration of spent cathodes from retired EV Li-ion batteries†

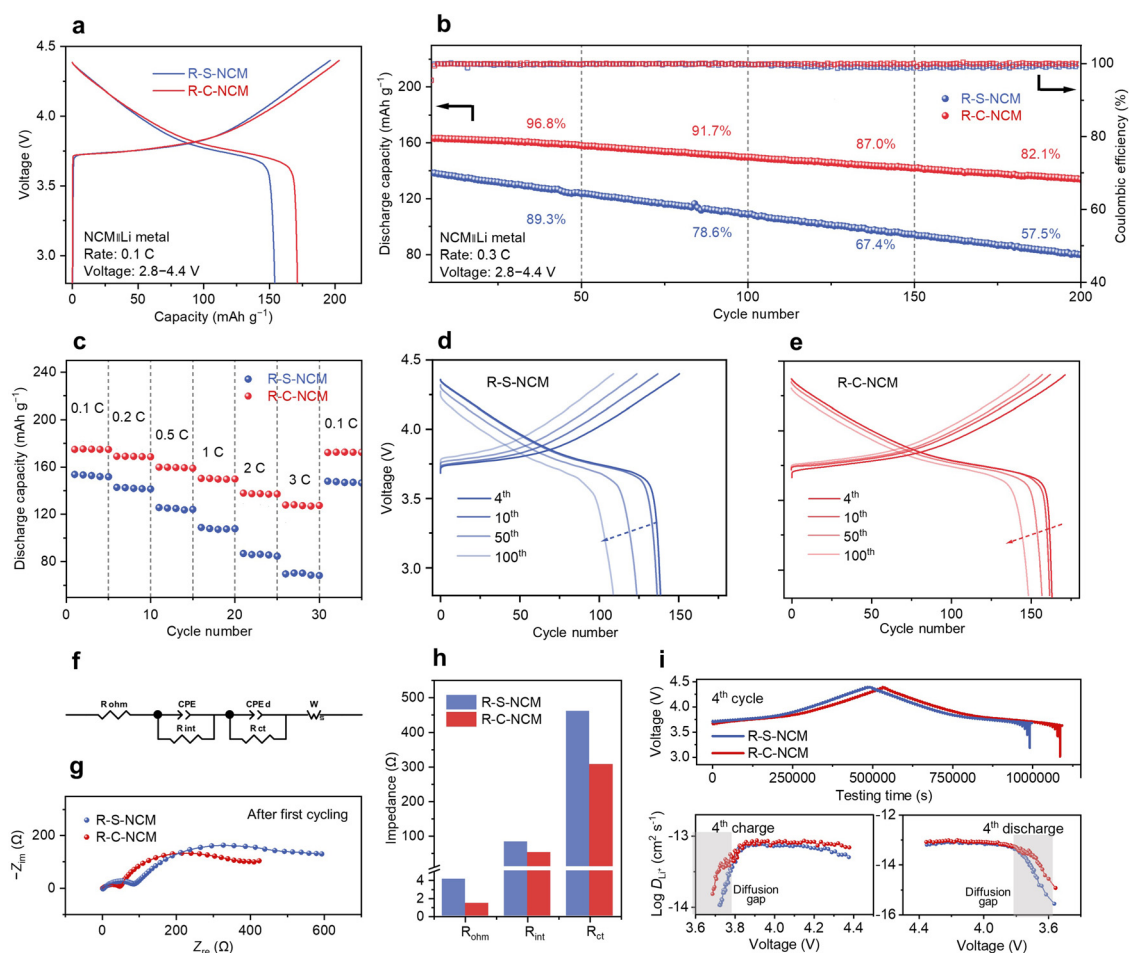
**Fig. 4** Electrochemical deterioration for the regenerated NCM cathodes with impurity residue. (a) Initial galvanostatic charge–discharge curves of R-S-NCM and R-C-NCM at 0.1C (1C = 150 mA h g<sup>-1</sup>) and (b) long cycling test and capacity retention in a half-cell. (c) Rate capabilities of R-S-NCM and R-C-NCM. Charge–discharge curves of (d) R-S-NCM, (e) R-C-NCM in the voltage range of 2.8–4.4 V (vs. Li/Li<sup>+</sup>) at different cycles. (f) Equivalent circuit applied in the EIS measurements. Nyquist plots of (g) R-S-NCM and R-C-NCM and (h) fitting results showing the Ohmic resistance ( $R_{ohm}$ ), interface resistance ( $R_{int}$ ), and charge-transfer resistance ( $R_{ct}$ ). (i) GITT curves and the calculated  $Li^+$ -diffusion rate of R-S-NCM and R-C-NCM for the 4<sup>th</sup> cycle number after activation in the same charge–discharge period. The shadow area indicates low  $Li^+$  diffusion in a certain voltage range.

As shown in Fig. 4a and Fig. S30 (ESI<sup>†</sup>), the initial discharge capacity increased from 154.1  $\text{mA h g}^{-1}$  for R-S-NCM to 171.4  $\text{mA h g}^{-1}$  for R-C-NCM after the purifying treatment, although this was slightly lower than for P-NCM. In Fig. 4b and Fig. S31 (ESI<sup>†</sup>), the R-C-NCM cathode exhibit 91.7% and 82.1% capacity retention after 100 cycles and 200 cycles, respectively, compared with 91.6% and 78.3% for P-NCM, and 78.6% and

57.5% for R-S-NCM, indicating the R-C-NCM cathode had better cycling stability, even compared to the pristine one. As for the rate performance, the R-C-NCM cathode demonstrated a better high-rate capability (Fig. 4c and Fig. S30, ESI†) at 3C ( $127.8 \text{ mA h g}^{-1}$ ) compared to R-S-NCM ( $69.8 \text{ mA h g}^{-1}$ ) and P-NCM ( $108.9 \text{ mA h g}^{-1}$ ), which was commonly observed on the regenerated NCM cathodes and may be attributed to appropriate F element doping.<sup>12,47</sup> The plateau at  $\sim 3.6 \text{ V}$  in the voltage profiles (Fig. 4d and e and Fig. S30, ESI†) for R-S-NCM nearly disappears after 100 cycles, suggesting that R-S-NCM had a rising polarization after long-term cycling. Based on the cyclic voltammetry curves at different scan rates and calculations (Fig. S31 and Table S12, ESI†), the fitting line slope for R-S-NCM was found to be the lowest among all the samples. According to the equivalent circuit (Fig. 4f), the calculated impedance values ( $R_{\text{ohm}}$ ,  $R_{\text{int}}$ , and  $R_{\text{ct}}$ ) of R-C-NCM (Fig. 4g and h) were 1.4, 51.1, and  $307.1 \Omega$ , respectively, and were smaller than that of R-S-NCM. These results indicate the deteriorated kinetics of  $\text{Li}^+$  transportation due to the residual impurities, especially on the surfaces of the regenerated cathodes. According to the chemical state of the electrode surface (Fig. S32, ESI†), R-C-NCM exposed less inorganic fluoride and more lattice oxide, leading to the suppressed interfacial resistance growing during the long-term cycling. Furthermore, the galvanostatic intermittent titration technique (GITT) test also revealed the kinetic characteristics of the solid phase. The current pulse profile and calculated Li-ion diffusion coefficient ( $D_{\text{Li}^+}$ ) after activation are shown in Fig. 4i. The average  $D_{\text{Li}^+}$  values of R-C-NCM and R-S-NCM were calculated to be  $5.78 \times 10^{-14}$  and  $2.99 \times 10^{-14}$  for the charge process (and  $4.56 \times 10^{-14}$  and  $4.29 \times 10^{-14}$  for the discharge process), suggesting that residual impurities penetrating the interior bulk after regeneration hamper  $\text{Li}^+$  hopping within the lattice of the NCM cathode, as supported by the observed F element (Fig. 3c and Fig. S27, ESI†).
