Cite this: *Energy Environ. Sci.*, 2025, 18, 9254Investigating the effect of lithiation on polycrystalline NMC811 Li-ion battery cathode cracking using *in situ* SEM micromechanical testingAigerim Omirkhan, <sup>\*ab</sup> Oriol Gavalda-Diaz, <sup>a</sup> Siyang Wang, <sup>a</sup> Ifan E. L. Stephens, <sup>ab</sup> Finn Giuliani <sup>a</sup> and Mary P. Ryan <sup>\*ab</sup>Received 18th February 2025,  
Accepted 16th September 2025

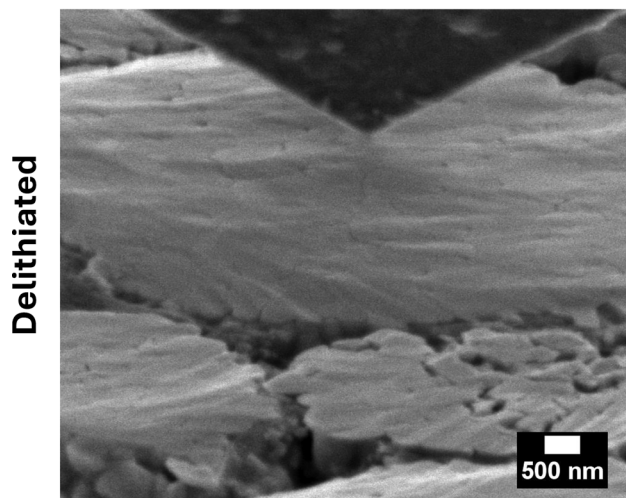
**Fig. 4** Snapshots extracted from a real time video recorded during *in situ* nanoindentation testing showing the cross-section of NMC811 sample and the cube corner nanoindenter tip (a) prior to and (b) following the application of a 3 mN load. The sample was charged to 4.2 V vs. Li/Li<sup>+</sup> and disassembled in the delithiated state.

*In situ* nanoindentation was used to corroborate single particle powder compression test results. Fig. 4 presents the snapshots taken during nanoindentation test, where the delithiated polycrystalline NMC811 particle cross-section was subject to 3 mN load. The hardness and elastic modulus of the pristine (lithiated) NMC811 particle cross-sections were compared to that of charged (delithiated) NMC811 particles in Table 1. The mechanical properties obtained from nanoindentation are in good agreement with those derived from powder compression, where significant reduction is seen at high SOC. Lithium ions shuttle out of the NMC811 structure during charging, resulting in a significantly weaker structure. As mentioned previously, TEM characterisation of delithiated NMC811 revealed the presence of rock-salt layer alongside layered and cation-mixed phases. This can result in significant anisotropic strain in the material. Fig. 4a and b reveal the presence of intergranular gaps at the boundaries between primary particles in the delithiated NMC811 sample at high SOC, observable as distinct separations along the grain boundaries. This apparent reduction in boundary strength, exacerbated by strain due to phase change, is one of the reasons for the decreased hardness observed in the nanoindentation tests. Voids between the primary particles of NMC811 at delithiated state are commonly occurring phenomena and were observed in TEM analysis (see SI1: Fig. S4a and b) as well as during Atom Probe Tomography (APT) sample preparation (SI1: Fig. S5).
