Decentralized UV disinfection systems in rural areas or low-resource contexts: a case study compilation

Water disinfection using ultraviolet (UV) light is an emerging tool for improving access to safely managed drinking water in rural areas and low-resource regions. However, there is little information comparing existing UV systems in those contexts, towards improving the effectiveness of future UV systems. This work presents 19 case studies of small, decentralized UV water disinfection systems being used during the last 30 years to improve water access. The case studies cover a wide range of project types, including schools, hospitals, communities, households and healthcare facilities, spanning four continents. A variety of energy sources, water sources and social environments are also reviewed. In general, the use of UV immediately improved the microbiological quality of the water; however, long-term tracking of system performance is largely missing. UV system effectiveness was limited by several factors, including the potential for recontamination after UV disinfection, insufficient maintenance, and the absence of regulatory frameworks that allow the more widespread adoption of

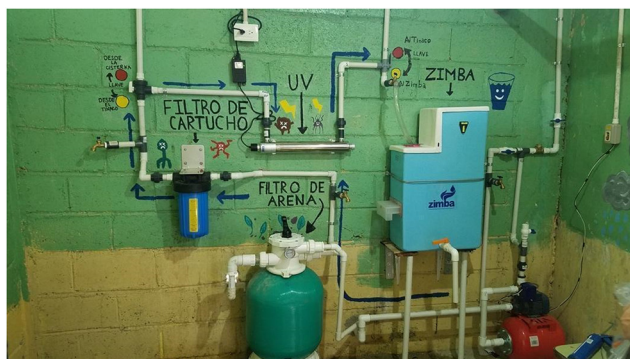
Fig. 5 Potable water treatment system installed in Escuela Primaria Aureliano El Mamey.

filtration and disinfection to produce finished water that is safe for drinking, cleaning and cooking at the schools. Treated water also can be routed to the handwashing station (Fig. 6). A sand filter is used to remove debris and large particles followed by a 1-micron cartridge filter for removal of microscopic particles, including bacteria and other microbial pathogens.

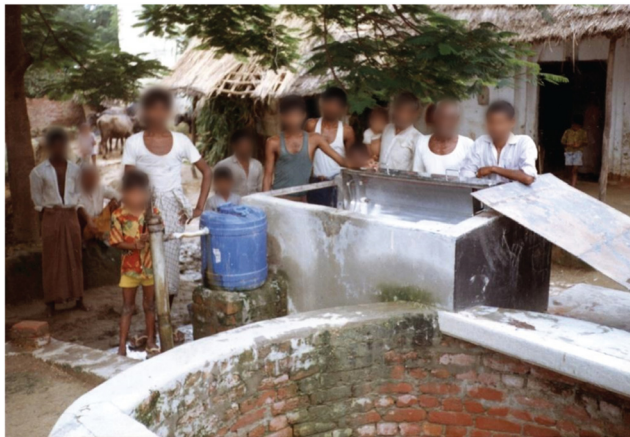
Fig. 12 View of the Bhupalpur field test. The open well in the foreground is in disuse. The hand pump to the left of the well supplies water to the blue surge tank, which feeds into a large early-design UV Waterworks unit, partly seen within the low-height concrete walls. The villager noted that the flow of this first design (60 LPM) was far larger than any hand pump flow the villager had ever encountered. This led to the more compact revised design that disinfected a water flow of 15 LPM, better matched to the UNICEF India mark-II hand pumps widely installed in the developing world.

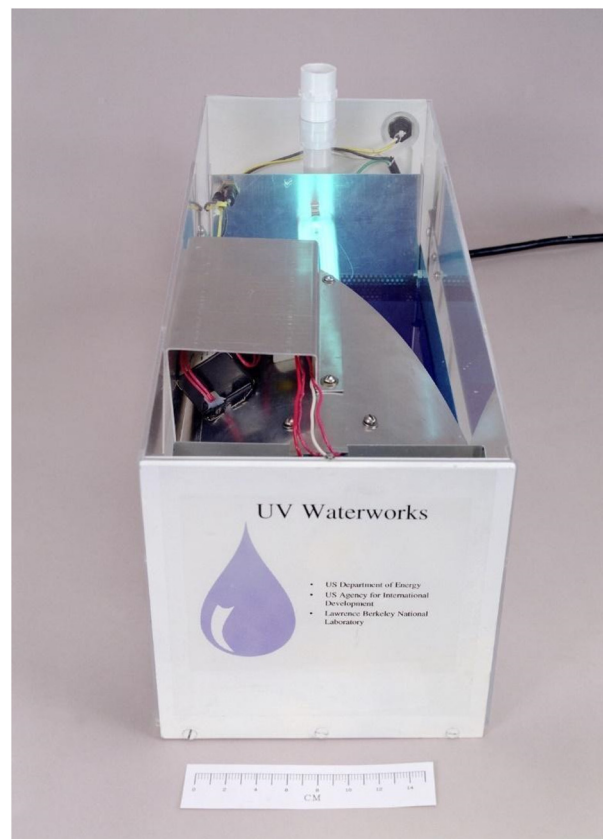
Fig. 13 UV waterworks, built with a glass cover for exhibits and displays to explain how the technology works.

The design team created an affordable and effective device that disinfects water using the equivalent of a 60 W light bulb at a cost of two cents per ton of water treated, treating 15 LPM, enough for 500 to 1500 people (Fig. 13). The unit delivers 120 mJ cm^{-2} to the water (three times higher than the 40 mJ cm^{-2} often recommended in the literature and regulations for drinking water disinfection, *i.e.*, ANSI/NSF-55 class A). It was designed to treat water with a UV extinction coefficient equal to that of the average effluent from United States municipal wastewater treatment plants. In laboratory testing with *E. coli* in dechlorinated tap water in Berkeley, UV Waterworks achieved a 6 log reduction in *E. coli* CFU (colony forming units). UV Waterworks was tested by third-party laboratories to ensure it could kill 15 different pathogenic bacteria (including *Campylobacter jejuni*, *Shigella*, *Salmonella typhi*, *Vibrio cholerae* and *Escherichia coli*) and multiple

influent, a system was created with no solid surfaces between the UV source and the water, ensuring that the UV disinfection remained unaffected by chemical or biological fouling. Positioning the UV lamp above the water flow also improves lamp life, output, and UV fluence. Operating in the air keeps the temperature stable, improving performance and longevity while preventing fluctuations that reduce UV output.⁴⁰ Avoiding contact with water minimizes fouling, corrosion and moisture damage, reducing maintenance needs.⁴¹

The initial design was constructed of welded stainless steel, at a cost of \$900 USD, consumed 40 W and reduced the bacterial colony forming units (CFU) per 100 mL at 30 LPM from 100 000 to less than one, *i.e.*, disinfection that meets WHO and EPA standards.

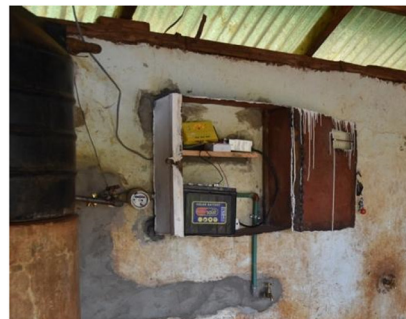
Fig. 18 System components that were designed and constructed by the welder; (left) a solar panel bracket holds the panel in place on the roof and locks so the panel cannot be stolen, and (right) a box to protect the system from tampering.

All of the UV system components were functional in 2020, but they were not being used consistently due to technical constraints. One major barrier was a problem with energy surges that were not properly mitigated by the charge controller in the system. There were issues with both locally and United States-sourced low-cost charge controllers. As a result, lamps would frequently burn out and need to be replaced. A surge protector was installed (which was unavailable locally), but the surges were frequent, requiring that an operator check the system before each use, which was not practical. Further, parts for the VIQUA VT1 system were not available locally and needed to be sourced from a company in Uganda (which needed to order them from Canada). Alternate UV systems were available at the local water equipment supplier, Davis and Shirtliff. Rigorous testing of locally available supplies and design of treatment systems using only these supplies would have prevented many of the technical issues encountered.

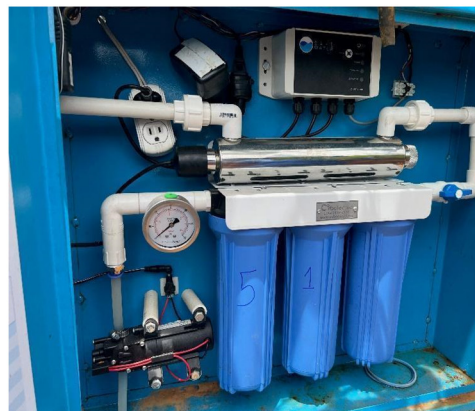
Fig. 20 The 250 L SAFEWATER system (left) with the encased LP UV lamp and activated carbon filters (right).

The second phase of the study (the SAFEWATER project from 2018 to 2022) was designed to deliver treated water for all uses in the household to minimize the risk from access to untreated stored water. During the study of 187 installations, the rate of positive *E. coli* incidences was reduced from 80% in the untreated control group to 20% in the treated systems. It was observed that only 16% of the households showed evidence of people sporadically drinking from non-treated stored water.

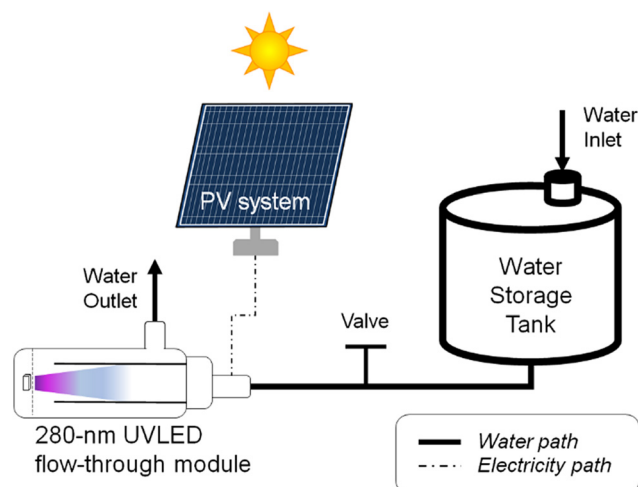
Fig. 23 Simplified schematic of the solar-powered UV LED water treatment system.

The UV LED was rated to operate at 12 V and 350 mA, which was powered by a 150 W commercial silicon solar panel generating approximately 325 Wh per day with a battery storage of 50 Ah (Fig. 23). The region has an estimated annual mean of 4.3 kWh m⁻² per day, as detected at Iloilo City. The system was only operated during the period of piloting.

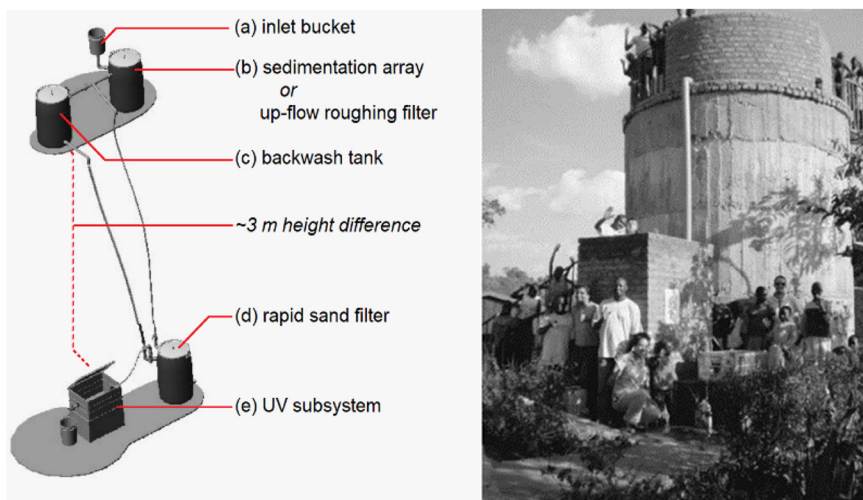
Fig. 26 A schematic of the BYOW system (left) and photo of the system installed in Mugonero (right).

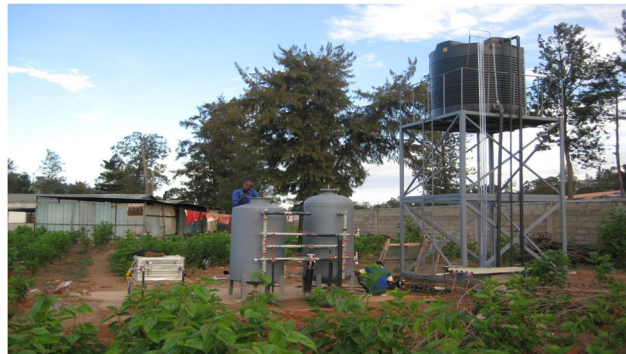
Fig. 27 An example of the Manna Energy Limited water treatment system. The system is installed in-line with existing water pipes. On the right is an elevated backwash tank. In the center is a gravel filter and a pressurized sand filter. On the left is the solar photovoltaic-powered UV system.

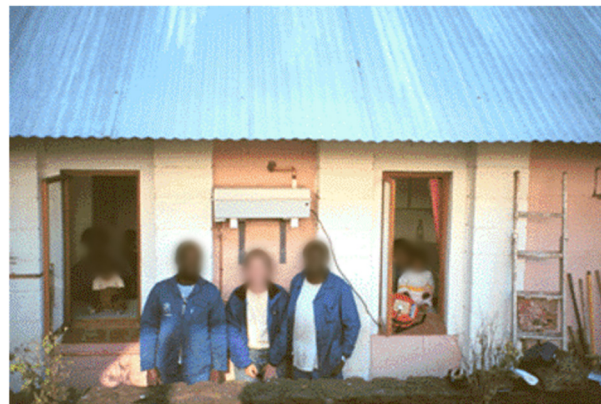
Fig. 29 UV Waterworks 2.0 unit installed on the exterior wall of the kitchen at the Lily of the Valley HIV-Hospice near Durban, South Africa.

The design team created a device to disinfect water using the equivalent of a 60 W light bulb at a cost of two cents per ton of water treated, treating 15 LPM, enough for 500 to 1500 people, depending on how many hours the unit is operated

daily and on how much drinking water per person is consumed daily. In laboratory testing with *E. coli* in dechlorinated tap water in Berkeley, UV Waterworks achieved a reduction in colony forming units (CFU) of *E. coli* by a factor of 99.9999% (*i.e.*, a million-fold reduction; *i.e.*, 6 log inactivation). UV Waterworks was tested by third-party laboratories to ensure it can kill 15 different pathogenic bacteria (including *Campylobacter jejuni*, *Shigella*, *Salmonella typhi*, *Vibrio cholerae* and *Escherichia coli*) and multiple pathogenic viruses (including rotavirus and poliovirus), and also cysts of *Giardia*. Specific capabilities of the device include:

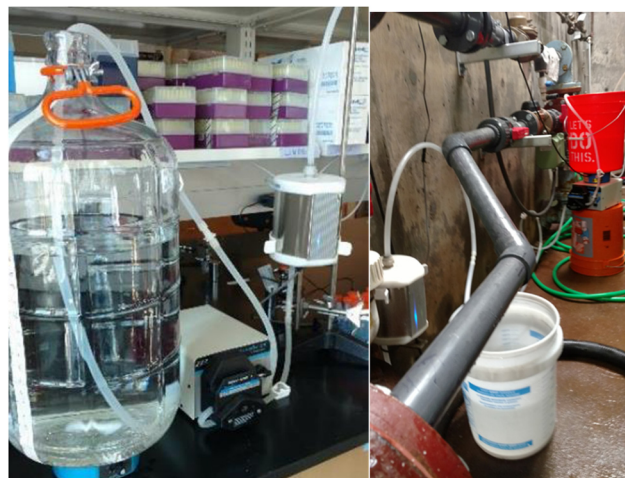
Fig. 35 UV LED reactor disinfection performance was assessed under varying conditions at bench scale (left) to develop a predictive model that was used to assess performance during challenge testing after pilot installation (right).

One objective of this research was to validate UV LED reactor disinfection performance at bench scale across a range of flow rates and UV transmittances to develop a predictive model for disinfection (Fig. 35). In the second objective, the LED reactor was installed in the first long-
