Cite this: *Energy Environ. Sci.*,  
2025, 18, 9254

# Investigating the effect of lithiation on polycrystalline NMC811 Li-ion battery cathode cracking using *in situ* SEM micromechanical testing

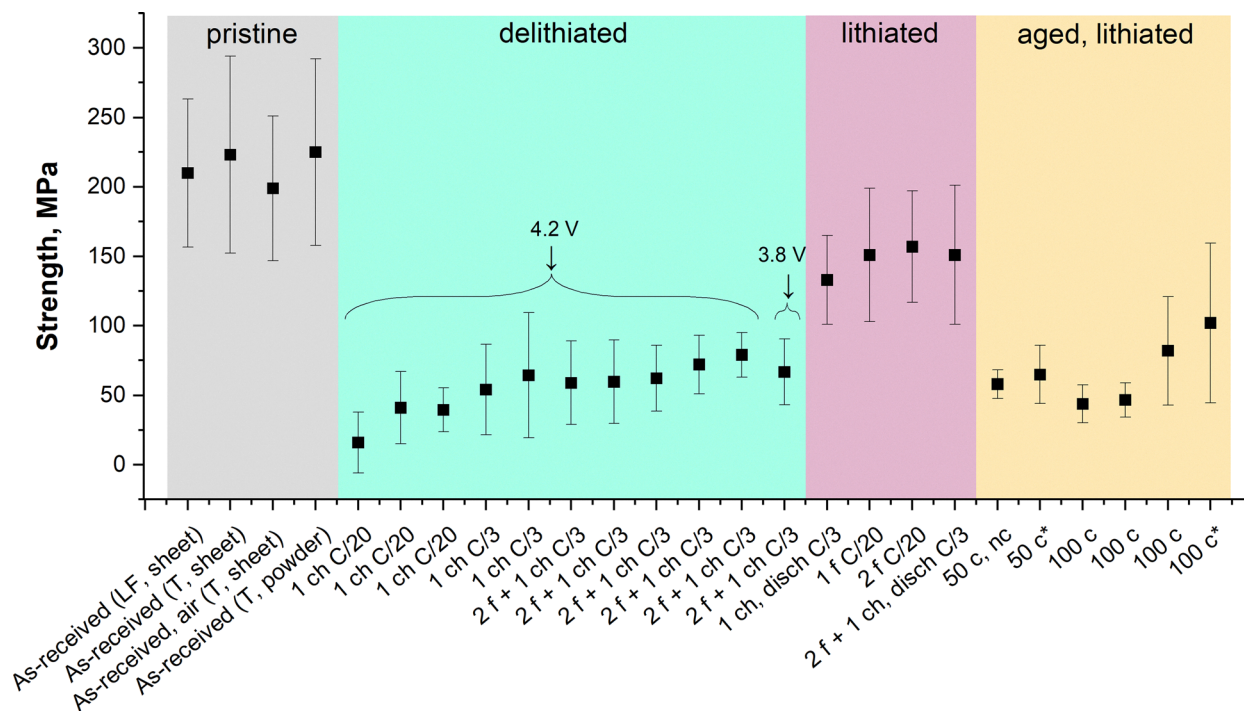
**Fig. 3** Average particle strength of polycrystalline NMC811 as a function of electrochemical cycling history, comparing pristine and cycled samples in delithiated, lithiated, and aged states. Error bars represent standard deviation. Pristine particles were either in powder form or extracted from cast sheet electrodes provided by two suppliers: Targray Technology International (non-calendered, T) and Li-FUN Technology (calendered, LF). Cycled particles were obtained from NMC811 vs. graphite coin cells cycled in LP50 electrolyte, unless marked with an asterisk (\*), indicating NMC811 vs. lithium metal cells. Aged samples are in the lithiated state. Electrochemical history is denoted using the following notation: ch – charged; disch – discharged; f – formation cycle; C/3 and C/20 – cycling rates. For example, “2f + 1 ch C/3” indicates 2 formation cycles (at C/20 rate) followed by 1 charge at C/3 rate, resulting in a delithiated cathode state.

**Strength of pristine NMC811 samples.** Fig. 3 presents the results averaged from 277 powder compression tests across 25 samples in pristine, delithiated, lithiated states, and aged after 50 and 100 cycles (see SI1, Table S1 for number of particles tested per sample). Broadly, there was no correlation between the particle strength and the diameter of the cycled particles (SI1: Fig. S6). The strength of the particles was calculated using Hiramatsu and Oka equation mentioned earlier. As-received pristine NMC811 cathode samples extracted from cast cathode sheets had strengths of  $210 \pm 53$  MPa and  $223 \pm 71$  MPa for calendered and non-calendered samples respectively. Since these samples were sourced from different suppliers, and given the standard deviation reported, we are unable to confirm if the calendaring process affected the strength of the particles. We have also exposed several particles to air for 2 hours and did not observe statistically significant strength reduction ( $199 \pm 52$  MPa). Pristine powder sample had strength of  $225 \pm 67$  MPa and is in good agreement with non-calendered cast electrode sample.

**Strength of delithiated NMC811 samples.** As mentioned in the previous section, the cross-section SEM images revealed the presence of cracks in the sample charged to 4.2 V at C/20 rate. These particles had the average strength of  $16 \pm 22$  MPa in non-calendered sample, while calendered samples had average strength of  $41 \pm 26$  MPa and  $40 \pm 16$  MPa across two samples, indicating a dramatic decrease in strength during the first delithiation event. Calendaring electrodes is known to enhance interfacial contact, which can improve rate capability during cycling.<sup>31</sup> During slow delithiation at C/20, differences in lithium extraction between calendered and uncalendered

Samples delithiated at C/3 rate had higher average strength *vs.* ones delithiated at C/20: with values between  $54 \pm 33$  MPa and  $65 \pm 45$  MPa. This most likely takes place due to overall lower SOC (more lithium in cathode structure) of the battery at C/3 *vs.* C/20 resulting in slightly stronger particles. In the delithiated samples, the average strength of samples with 2 formation cycles was 23 MPa higher than those without formation cycles, highlighting the importance of formation cycles in informing battery degradation among other well-known benefits. Formed samples had average strength values between  $59 \pm 30$  and  $79 \pm 16$  MPa. Note that this is more than 70% reduction of strength seen during the first few cycles in delithiated samples compared with pristine samples.

**Strength of lithiated NMC811 samples.** Notably, in the samples that were (re)lithiated, *i.e.* charged and discharged at C/20 during 1 formation cycle, we see a partial recovery of mechanical properties to  $151 \pm 48$  MPa. There is an inverse correlation between the state of charge, *i.e.* degree of delithiation, of NMC811 particle and its strength (Fig. 3: see delithiated *vs.* lithiated samples). Particles at low SOC have higher strength than particles at high SOC. The partial recovery of mechanical strength of the particles could be attributed to partial intergranular crack closure upon (re)lithiation in early stage cycling as reported in the literature (*operando* XCT studies mentioned in the previous section<sup>26,32</sup>). It is worth mentioning that once the crack forms during delithiation, it does not fully close when (re)lithiated (one would expect the particle strength to revert to original value if crack ‘healed’). Nevertheless, we can see that the interparticle grain boundary strength that we probe with *in situ* SEM powder compression is partially regained when lithium ions shuttle back into the NMC811 structure. Recent publication discusses structural changes taking place during NMC811 charge–discharge.<sup>8</sup> Specifically, using *operando* XRD authors reveal a universal mechanism where strain and lattice distortions intensify below a critical lithium content (around 40%). When lithium content in NMC811 lattice went below this critical value, exponential strain and large lattice distortions were measured. In early cycles, the anisotropic strain was measured to be reversible and suggests that initial structural distortions caused by lithium extraction can be recovered upon (re)lithiation. This directly impacts crystalline cracks, which are closely linked to anisotropic strain and lattice distortions. This agrees with our observations, where the strength is partially regained during (re)lithiation. For operating voltages between 2.5–4.2 V authors didn’t see any  $H_2 \rightarrow H_3$  phase transition (hexagonal with lattice constant  $c_{H_2} > c_{H_3}$ ), often blamed for capacity fade in nickel-rich layered materials. Similarly, a

**Strength of aged NMC811 samples.** Finally, we can see in Fig. 3 that aging NMC811 material *via* extended cycling results in further reduction of the particle strength compared to as-received and lithiated samples. Across 6 aged samples, the particle strength after 50 cycles was  $58 \pm 10$  MPa (full cell) and  $65 \pm 21$  MPa (half-cell); while the variation after 100 cycles was quite prominent with average strength values between  $44 \pm 14$  MPa and  $82 \pm 39$  MPa measured for full cells, and  $102 \pm 58$  MPa for half-cell configurations. Interestingly, this gradual reduction during aging is recorded both in high-capacity cells and cells with average performance (SI1: Fig. S8) as cycle-on-cycle capacity reduction is measured in all aged samples. This is likely caused by formation of permanent cracks (*i.e.* cracks that reach the surface of the particle and do not reduce in size on cycling), through layered structure transformation into the spinel and rock-salt structures, increasing lattice mismatch between these structures. Indeed, it was reported that prolonged cycling in polycrystalline NMC811 particles is associated with atomic-level transformations including rock-salt layer formation on crack surfaces, transition metal dissolution consistent with rock-salt layer, as well as strain and lattice distortions using scanning transmission electron microscopy (STEM) and electron energy loss spectroscopy (EELS).<sup>29</sup> Another study presented the TEM results of aged NMC811 samples after 100 cycles, where electrochemically inactive rock-salt layer
